Use of earth observation products to enhance humanitarian disaster response

A Case Study of KRCS Response to West Pokot Mudslides in 2019

Authors: ● Michael Osunga ● Betty Makena ● Halima Saado Abdillahi

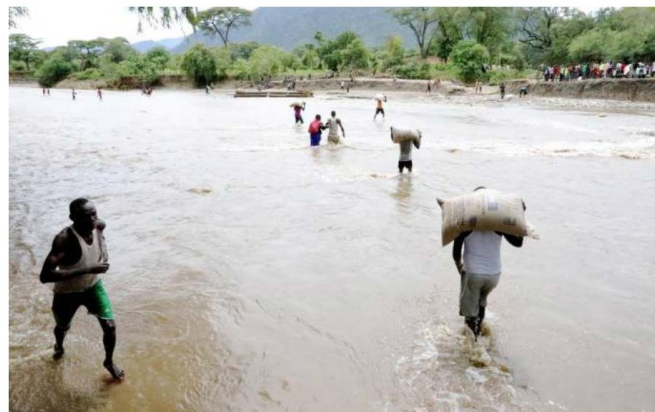
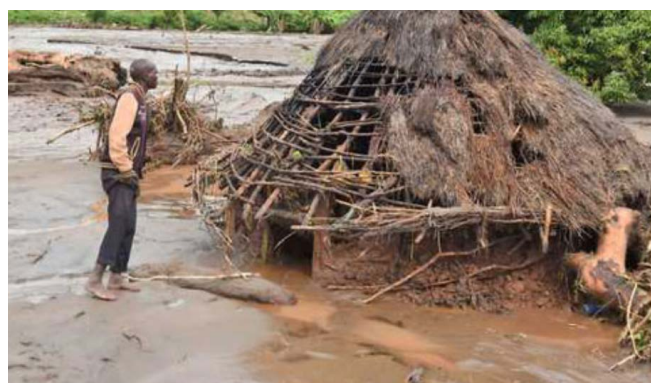
Residents assist in carrying people and goods across the Weiwei river in West Pokot County. Weiwei bridge was damaged by floods. Sebit bridge was also washed away cutting off transport between Kitale and Lodwar. [Kevin Tunoi, Standard]

Figure 2: Weiwei River cut off by floods and houses destroyed at Serbit in West Pokot County. Image sources: The Standard (28th November 2019) and Nation Media Group (23rd November 2019)

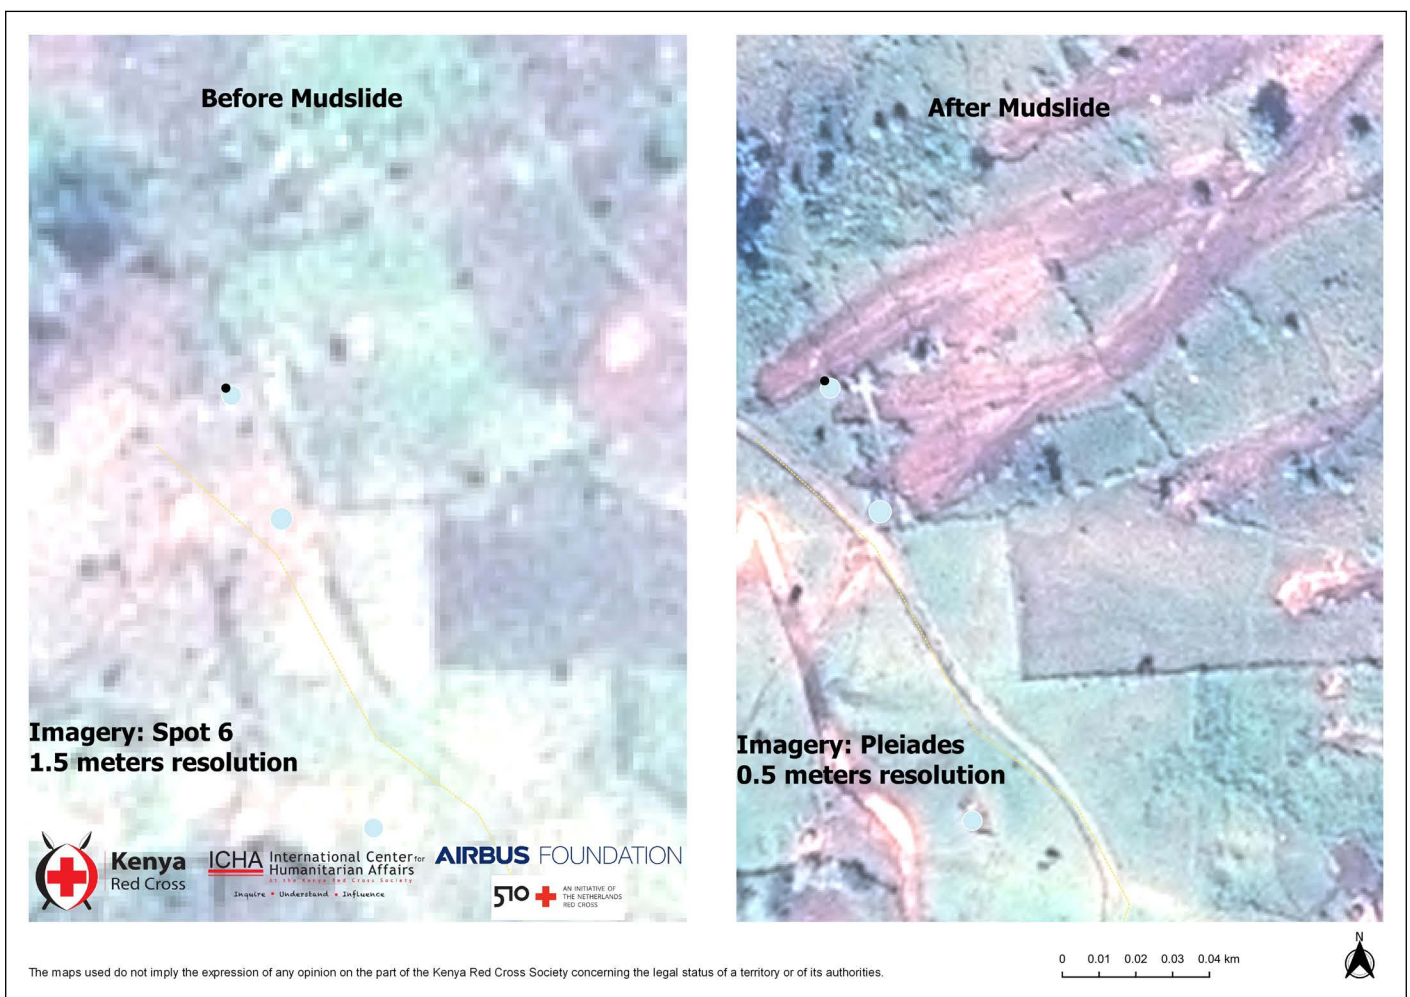
Figure 7: Change detection – visual comparison of spot 6 and Pleiades imageries was done in order to visually interpret landslide scars

The left image highlights farmlands as they were before the mudslide event. The image on the right shows farmlands that were destroyed by the mudslide. The affected farmlands were left bare as a result of the mudslide.

were overlaid side-by-side in order to visually interpret mudslide scars. These scars were converted into vector data by tracing features through onscreen digitization. Figures 7 to 11 below illustrate the visual comparison of spot 6 and Pleiades imageries to determine landslide scars. The figures have been overlaid with rivers; in blue, houses; in black and roads; in yellow to visualize the situation before the mudslide event using the spot 6 imagery (at a coarser spatial resolution of 1.5 meters) while comparing it with the situation after the mudslide event using the Pleiades imagery (at a finer spatial resolution of 0.5 meters). The two images have been overlaid at the same map scale for visual comparative analyses.
